Process Plant Tent Responses to Vapor Cloud Explosions—Results of the American Petroleum Institute Tent Testing Program

API TECHNICAL REPORT 756-1
SEPTEMBER 2014

Prepared for API by:
Raymond H. Bennett, P.E., Ph.D.
Martin Goodrich, P.E.
Brad Horn

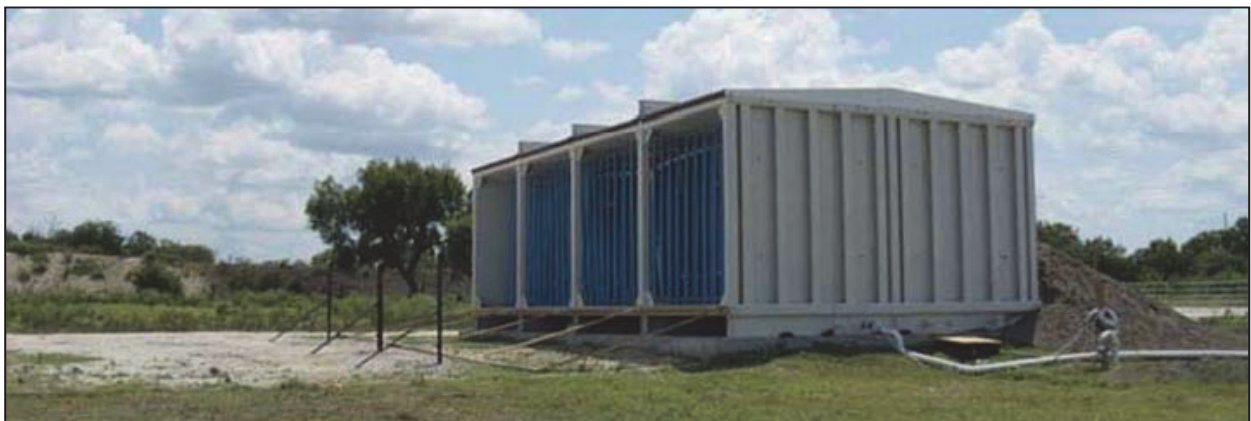
Figure 1. VCE Deflagration Load Generator Test Rig

BakerRisk designed and constructed the Deflagration Load Generator (DLG) test rig used for these tests. The test rig measures 48 ft. long by 24 ft. deep by 12 ft. tall and has three rigid walls, a rigid roof and floor, and one open wall facing the structure being tested, as shown in Figure 1. The interior of the rig is fitted with congestion. The test rig is filled with a propane/air mixture and ignited, causing a VCE.

The specific test environment is controlled through selection of fuel concentration, obstacle geometry, and the distance between the test article and the VCE test rig. The tests were deflagrations with moderate flame speeds such that the wave shape of the blast load would include a rise time to the peak pressure. This type of VCE is representative of typical accidental VCEs at industrial facilities.

The VCE deflagrations are set to vent outside the test rig, toward the test articles. The tents were placed at a sufficient range from the test rig such that three test articles could be tested simultaneously on each shot. The test rig was configured such that the blast loading on the tent could be changed by varying the fuel concentration rather than relocating the test articles.
