STP-NU-068

**CORROSION OF  
A193 GRADE B7  
BOLT MATERIAL IN  
BWR SODIUM  
PENTABORATE SOLUTIONS**

Date of Issuance: March 14, 2014

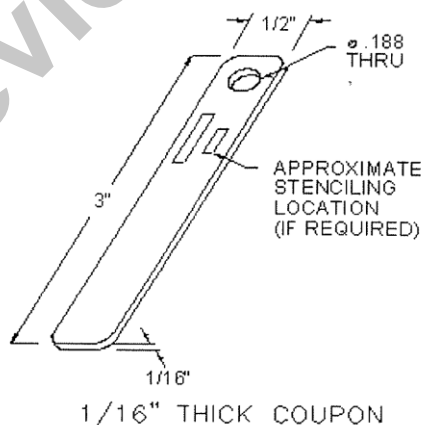
Figure 2-1 Coupon Design

Composition of the coupons is shown in Figure 2-2 [3]. Dimensions are shown in Figure 2-1. Total area of each coupon was  $\sim 3\text{ in}^2$  or  $0.194\text{ dm}^2$ . The coupons were finished using a 120 grit belt prior to exposure [3]. The pH and conductivity of the 12% NaPB solution at  $\sim 25^{\circ}\text{C}$  were 7.08 and  $11,600\text{ }\mu\text{S/cm}$ , respectively.
