IPC-WP-113

Guidance for the Development and Implementation of a Red Plague Control Plan (RPCP)

Developed by the Wire Harness Design Task Group (7-31k)
and IPC-HDBK-620 Handbook Task Group (7-31h) of the
Product Assurance Committee (7-30) of IPC

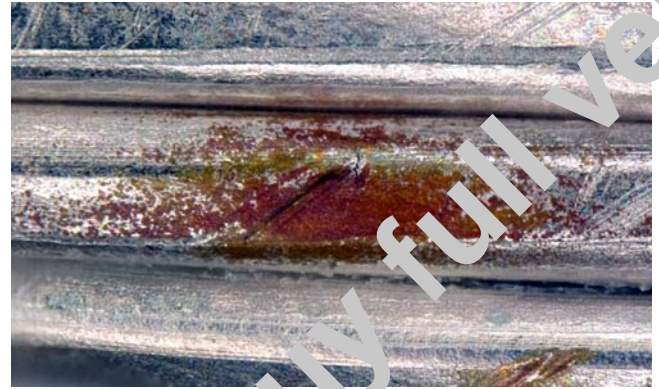
Figure 1-1 Red Plague (Cuprous Oxide Corrosion)
Photo Courtesy of NASA

Red Plague (cuprous oxide corrosion) can develop in silver-coated soft or annealed copper conductors (component leads, single and multi-stranded wires and PCB conductors) when a galvanic cell forms between the copper base metal and the silver coating in the presence of moisture (H_2O) and oxygen (O_2). Once initiated, the sacrificial corrosion of the copper base conductor can continue indefinitely in the presence of oxygen, progressively reducing the electrical and mechanical integrity of the conductor (the degradation is particularly acute in thin conductors). The color of the corrosion by-product (cuprous oxide crystals) may vary depending on the different levels of oxygen available, but is commonly noted as a red/reddish-brown discoloration on the silver coating surface.

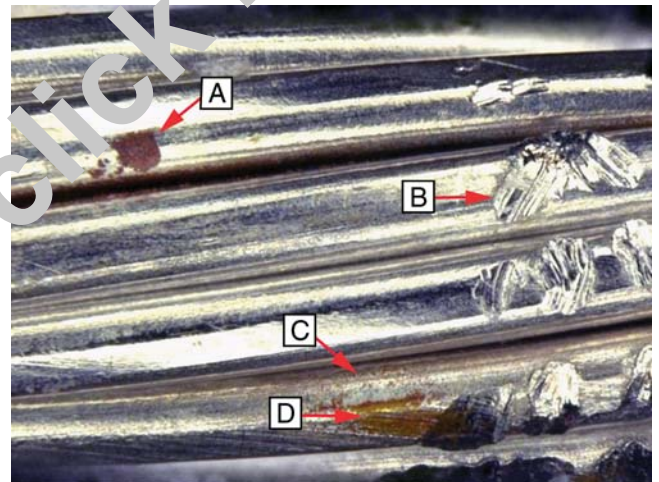
Figure 1-2 Close-Up View
AS22759 Stranded, Silver-Coated Copper Wire
Showing Varying Stages of Red Plague, Damaged
Plating, Mechanical Damage, Porosity, and Exposed
Copper

- A. Damaged Plating Site (Red Plague)
- B. Mechanical Damage (Recent)
- C. Porosity Sites with Red Plague
- D. Exposed Copper with Red Plague

Mechanical Damage The primary initiator of Red Plague is mechanical damage of the silver coating during wire manufacturing (i.e., drawing, stranding, application of insulation jackets, etc.) resulting in exposure of the copper-silver interface to atmospheric moisture and oxygen. Other common sources of mechanical damage include improper assembly and installation practices (i.e., excessive flexing, improper bend radius, etc.).

Inadequate Silver Coating Thickness Porous, discontinuous, and thin silver coatings are more likely to develop Red Plague since a greater number of sites for galvanic cells to form between the copper base metal and the silver plating are possible. Silver coating thicknesses below $1\ \mu m$ [$40\ \mu in$] are more easily damaged during manufacturing and handling, thus increasing susceptibility. Increasing the silver coating thickness to $2\ \mu m$ [$80\ \mu in$] has shown improved resistance to corrosion.
