Guide to the Code for Assessment, Repair, and Rehabilitation of Existing Concrete Structures

A Companion to ACI 362-19

ACI MNL-3(20)

Third Edition

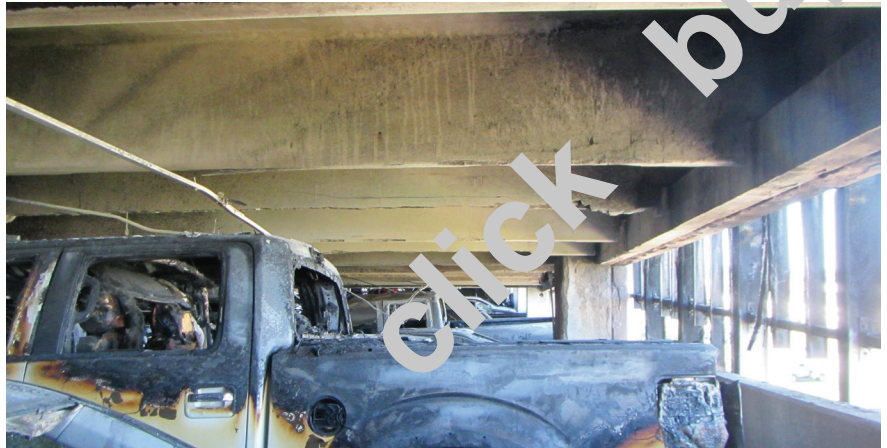
Fig. 2—Fire damage on Level 3 of parking garage

In April 2018, a multiple-vehicle fire occurred on the third level of the four-level University of Houston East Garage (Fig. 2). Significant structural damage occurred to two columns, the framing of the level above, and the exterior signage (Fig. 3). Before a survey of the damage could be completed, shoring was installed as a precaution to prevent the possible collapse of damaged members (Fig. 4).

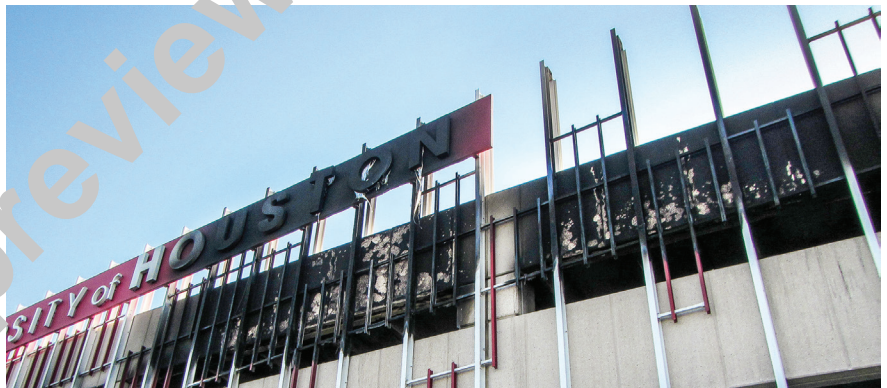
Fig. 3—Fire damage at exterior of garage

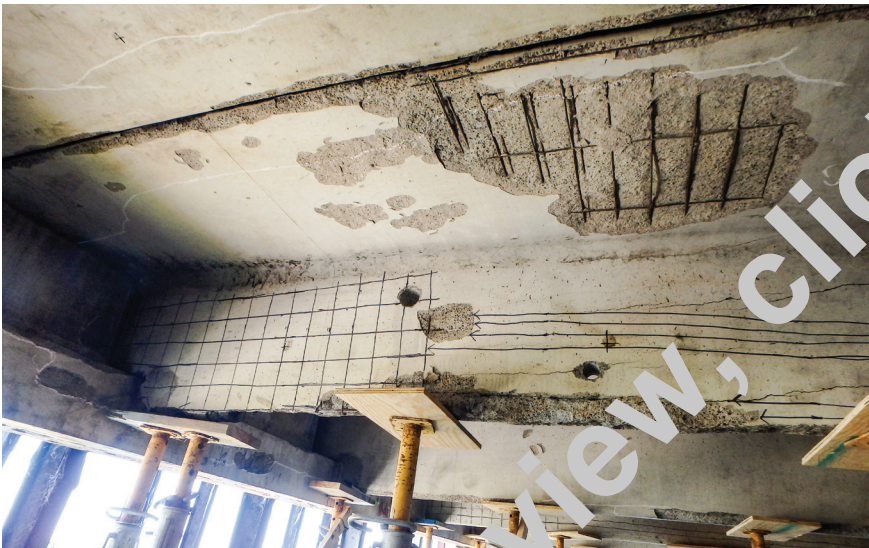
Fig. 6—Concrete cracking and spalling due to fire

The visual reviews and delamination survey indicated that fire-related distress had occurred in the form of concrete cracking and spalling, including delaminations identified in several crucial structural beams and columns (Fig. 6). The concrete distress was more severe at members near the expansion joint. Core compressive strength testing did not show degradation of compressive strength as a result of the fire event. However, the petrographic examination of the concrete cores indicated the extent of surficial concrete damage as a result of exposure to fire-elevated temperatures was up to a depth of 0.4 in. (10 mm).

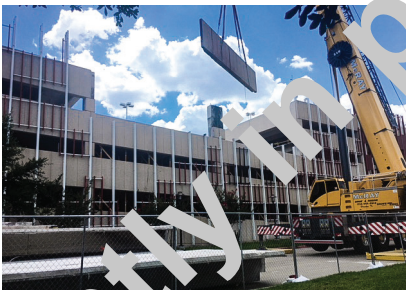
Fig. 7—Spandrel beam replacement

reinstalled in their original position. Two spandrel beams were hoisted down, removed from the site, and replaced with new members (Fig. 7). New replacement double tees were hoisted into place for final repairs (Fig. 8).

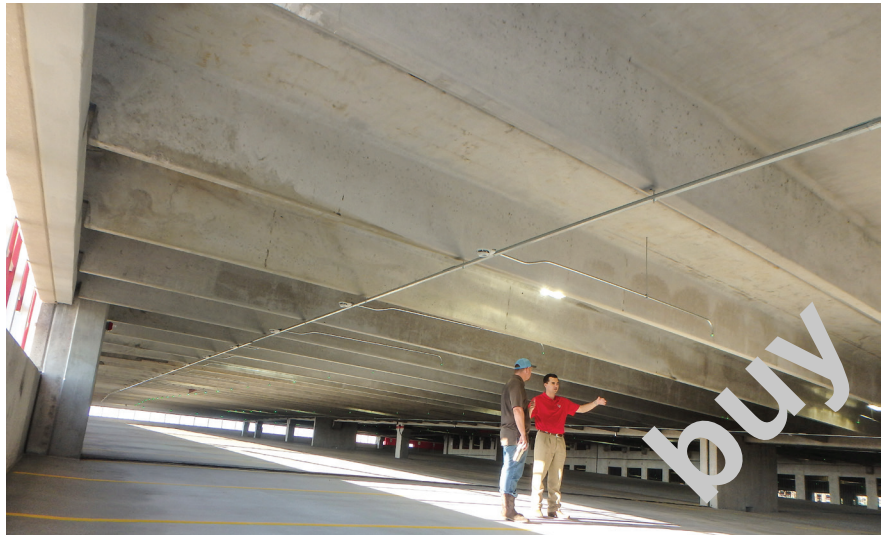
Fig. 8—New replacement double-tee beams at completion

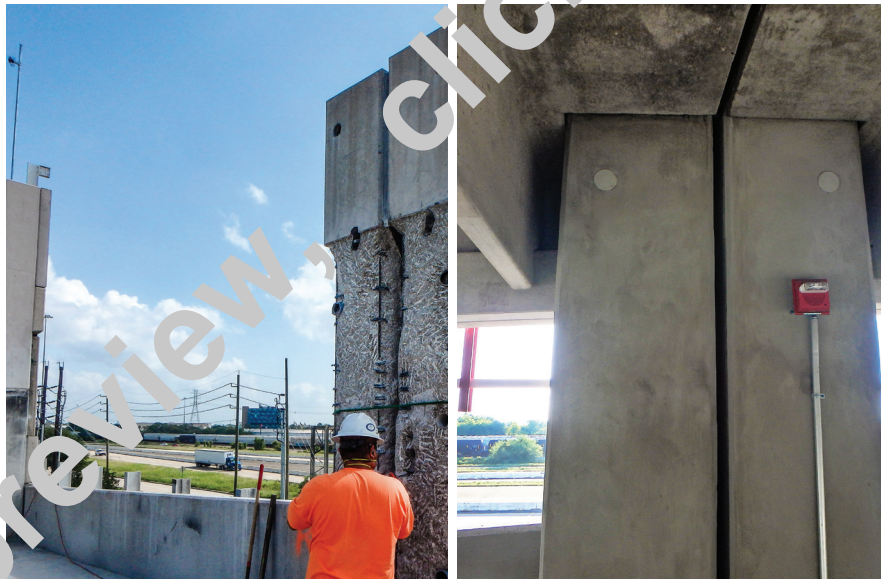
Fig. 9—Column during repair (left) and after repair (right)

Other repair works included the repair of concrete columns supporting Level 4 (Fig. 9), spandrel beams on Levels 3 and 4, double-tee members on Level 4, topping slab replacement on Level 3, and waterproofing installation on Levels 3 and 4. The damaged expansion joint system on Level 3 was replaced and a new expansion joint system was installed on Level 4. Joints were tooled in the topping slab and sealed above the double-tee flange-to-flange joints, and construction joints were routed and sealed. Cove sealant was installed at the perimeter bumper wall and columns.
