IPC-9121

# Troubleshooting for Printed Board Fabrication Processes

Developed by the Printed Board Process Effects Handbook  
Subcommittee (7-21) of the Process Control Management  
Committee (7-20) of IPC

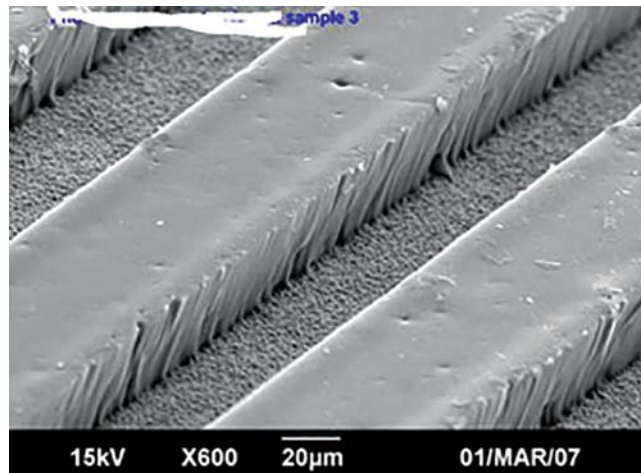
Figure 1-1

#### Issue: Photoresist under-exposure

CAUSE	ACTION
UV source inadequate	Check exposure intensity/wavelength/duration
Expose intensity inadequate	Review, reinstated exposure control procedures
Expose time inadequate	Review, reinstated exposure control procedures
Oxygen exposure of photoresist prior to exposure	Review photoresist shelf life
Potential test methods (discover)	Potential test method (verification)
AOI (line/space reproduction) Etch-outs	AOI Periodic UV photometer and step tablet exposure checks
