Compressed Gas Association

CGA-P-94-2022
GUIDELINE FOR DETERMINING
THE EXTENT OF EXTERNAL
VESSEL CORROSION ON FOAM
INSULATED MC-331 CARBON
DIOXIDE AND NITROUS OXIDE
TANK TRAILERS

FIRST EDITION

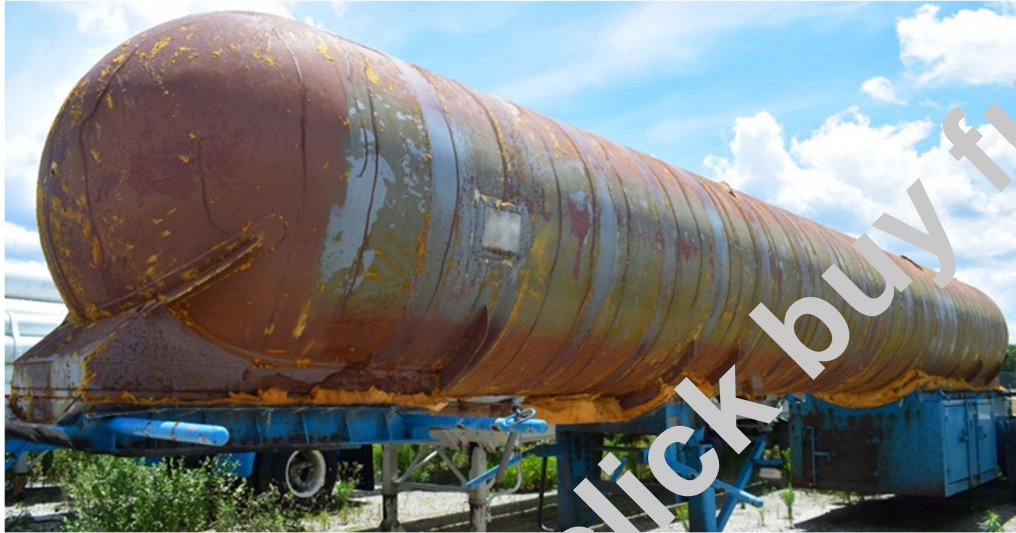
Figure 1—Example of trailer with insulation removed

Some carbon dioxide and nitrous oxide trailers have been in service for 40 and 50 years without having had the foam removed for inspection of the vessel exterior. When these units are removed from service for refurbishment, extreme surface corrosion can be discovered, including areas that are pitted, corroded, or rusted. This corrosion is caused by water condensing between the foam and the tank surface as the tank cools and warms during filling and emptying. The corrosion and subsequent loss of pressure vessel shell thickness is a safety issue and is a primary reason for removing these tanks from service. See Figure 1 for an example of a tank trailer with the insulation removed.
